ALPINA DAM

(Inventory Number 778)

St. Lawrence River Basin
LEWIS COUNTY,
NEW YORK.

PHASE I INSPECTION REPORT,
NATIONAL DAM SAFETY PROGRAM

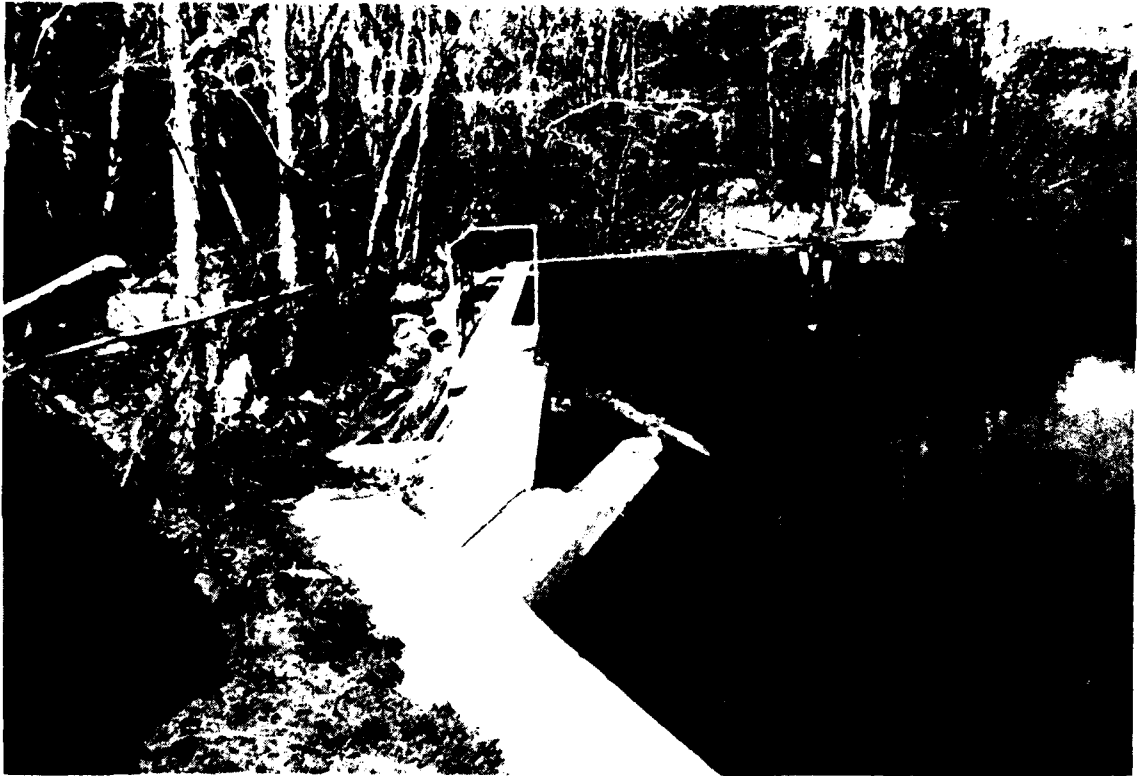
Overview of dam spillway system taken from small west
earth embankment area.

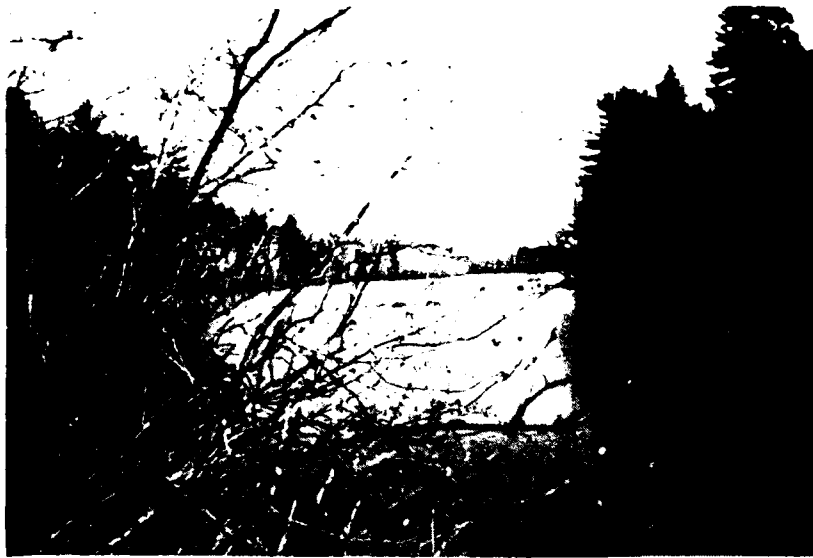
3. View of reservoir above dam.

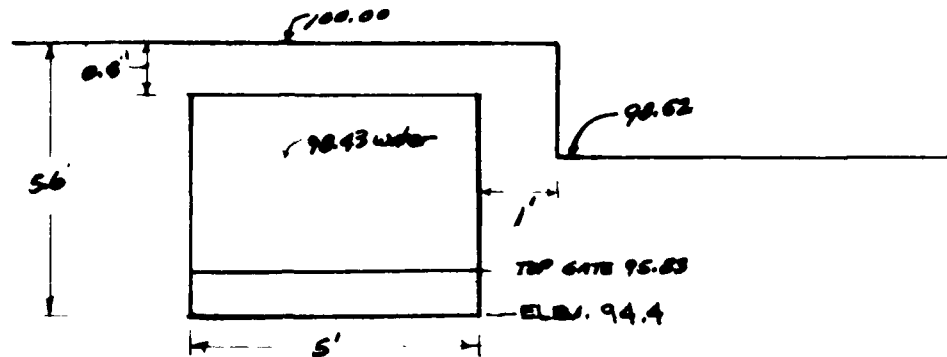
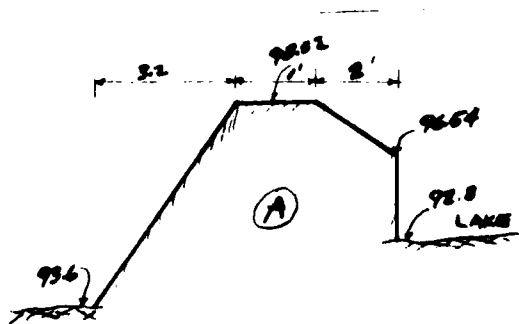
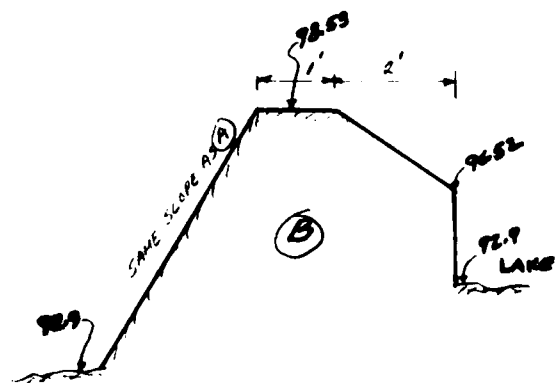
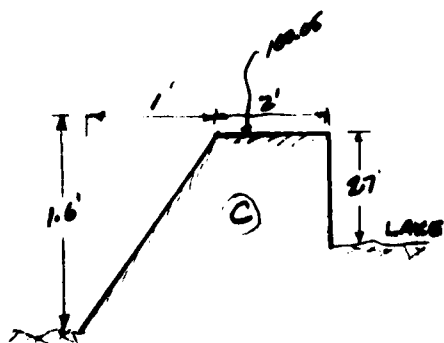
No information relating to the design and construction of the dam structure has been made available. A field survey undertaken as part of this Phase I study has provided information on dam cross-sections (Figures 2 & 3) but did not extend to determining properties of the dam's concrete and foundation rock. Stability evaluations have been performed, utilizing the obtained cross-section information to obtain an indication of the dam's performance when subject to different possible loading conditions. In these analyses, assumptions were required in regard to concrete and rock properties, the geometry of the dam, and cross-section for the assumed critical location.

The analysis indicates unsatisfactory stability against overturning for certain combinations of loading conditions.

Somewhat surprising is the instability indicated for a normal reservoir elevation with ice acting, a condition presumed to have occurred in the past without effecting damage. The practice of lowering the reservoir level in winter may have resulted in ice pressures being resisted by the abandoned submerged dam section immediately behind the newer structure. The narrow shape and relatively small size of the impounding area immediately behind the dam may also influence and limit the extent of ice forces being imposed against the dam structure, the expansive pressures due to daily temperature variations being accommodated by encroaching upward on the reservoir's sidebanks. Limited tensile strength from the bond between dam concrete and rock formation also could be acting to assist stability.
